Bravo

Troubleshooting Guide

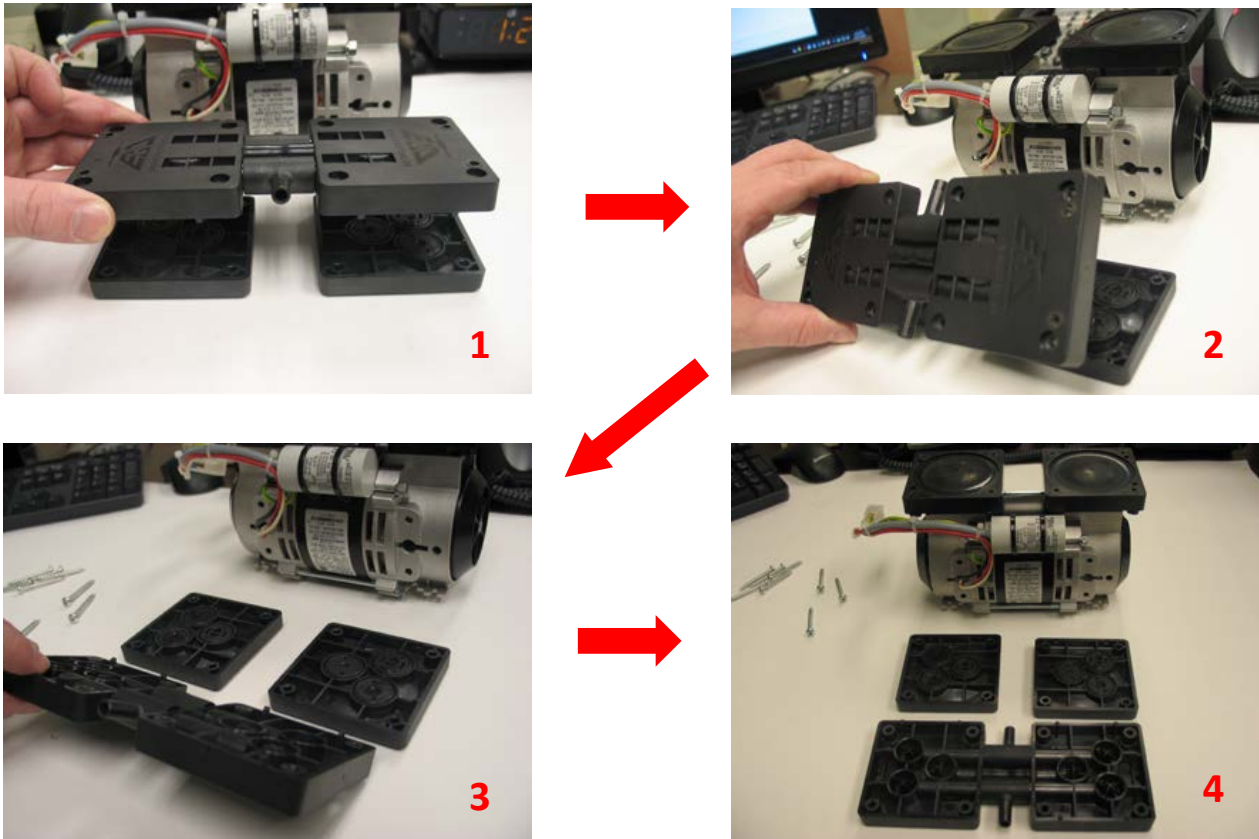
9. Now lift up and flip over the top section, maintaining orientation as shown.

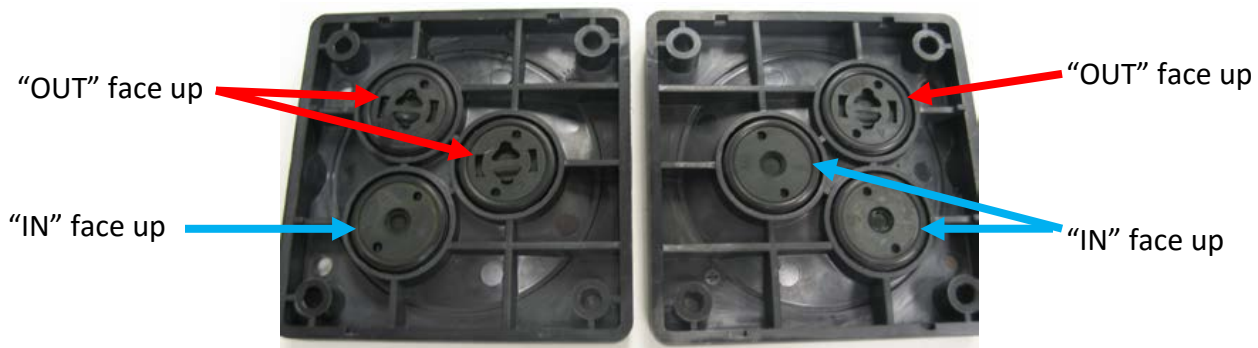
10. Now we can replace the primary o-rings and shutter-disks of the two heads. Note the asymmetrical layout of these disks as shown below. (If the disks appear different, see next step)

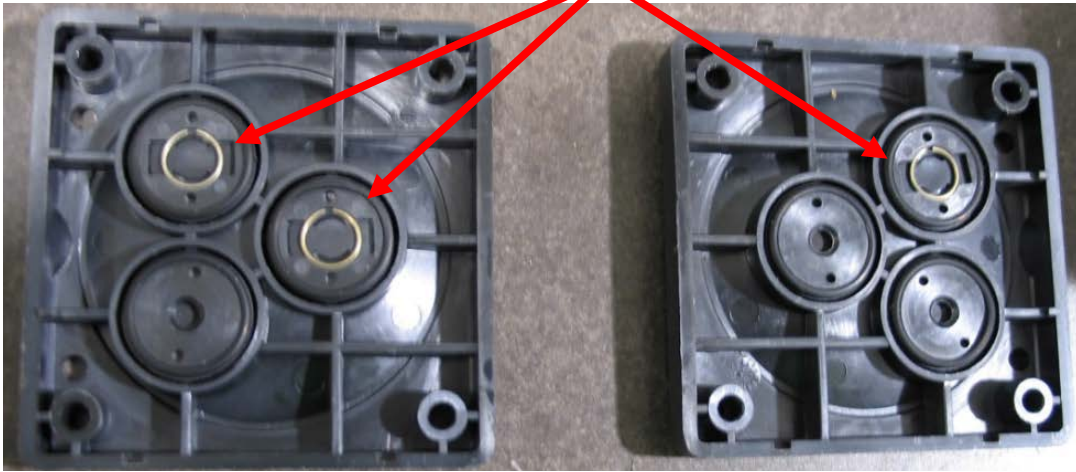
C-Clip style shutter-disks

11. In some older style vacuum pumps, the shutter-disks used small c-clips to hold the shutters in place. If your pump has these older shutter-disks with c-clips, no need to worry, simply replace them with the new shutter-disks provided with your rebuild kit.

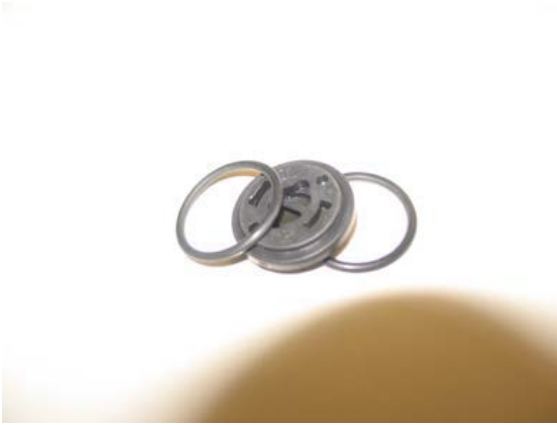
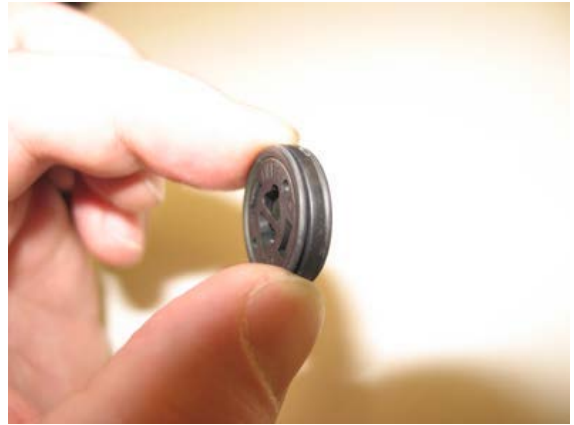
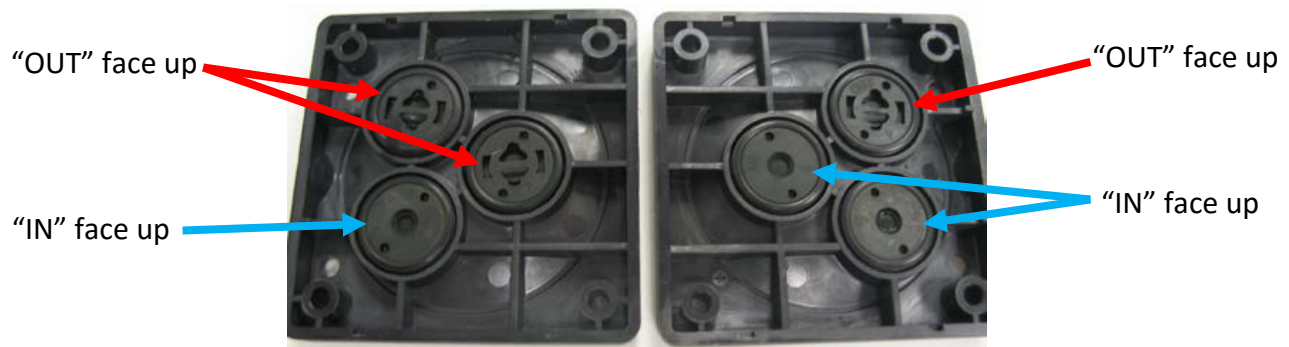
12. Remove all shutter-disks and o-rings (6 disks, 12 o-rings total). Each disk has two o-rings around its outer edge (one on each side), be sure to remove them all. Place two new o-rings on each new shutter-disk and set them in place, oriented the same as they were (as shown below).

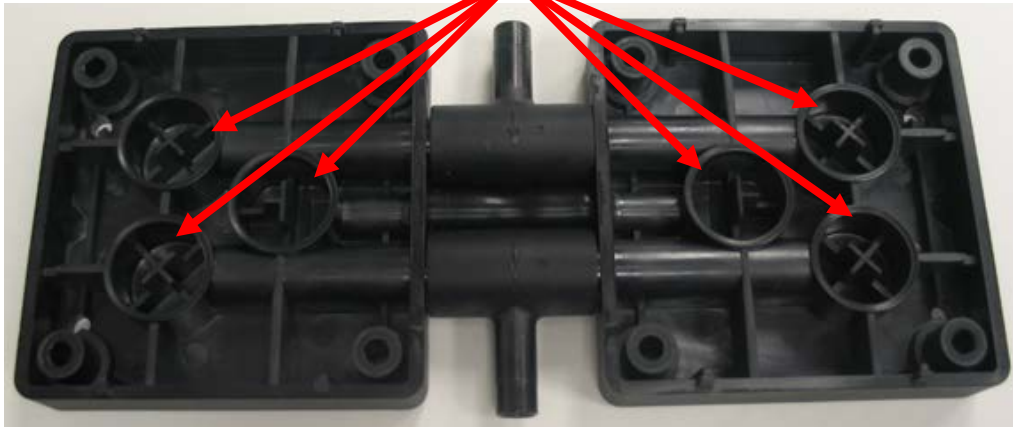
Check for old o-rings

13. Now we can address the other section of the head units that we removed in step 9. Make sure there are no o-rings left behind from the old shutter-disks in any of the six round fittings

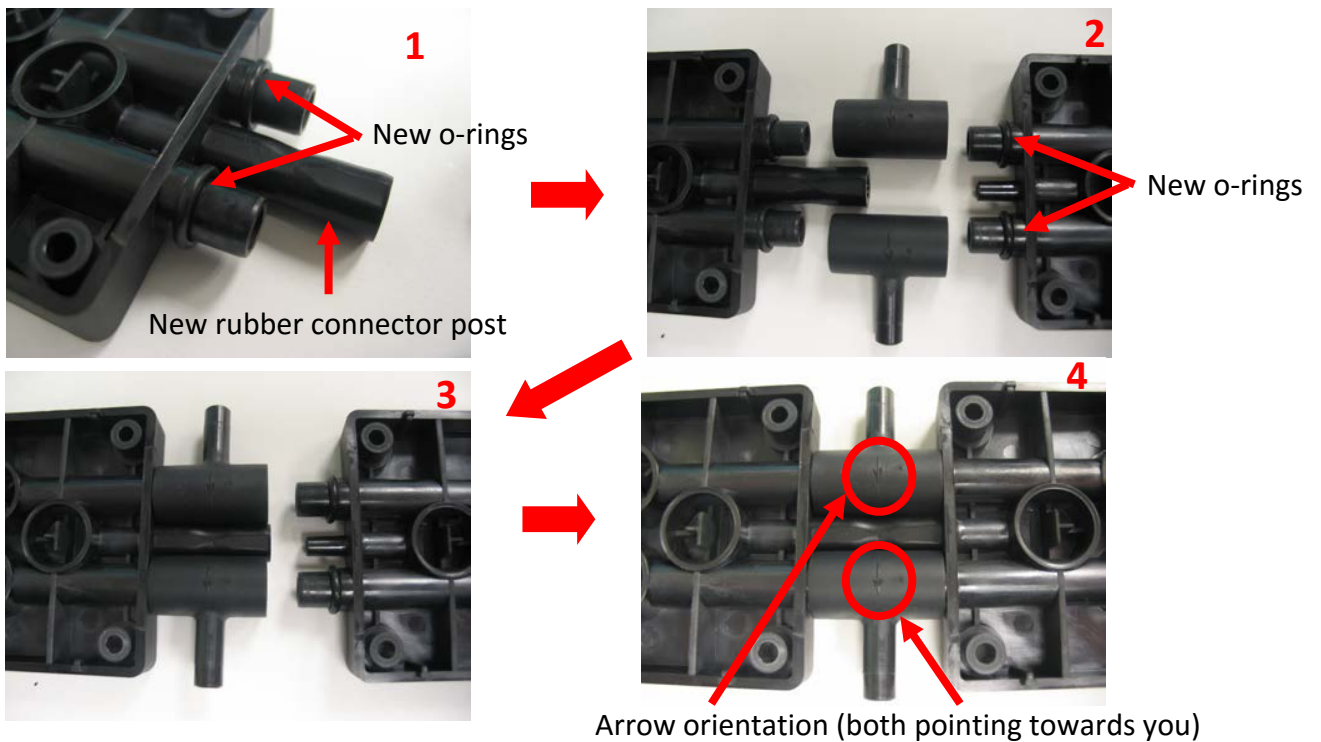
4 small o-rings

15. Replace the four small o-rings by sliding them onto the posts of the heads. Slide the new rubber central connector onto one of the heads, then press the two heads together as shown, maintaining the same orientation. At this point, the two black arrows on the barb connection pieces will be pointing towards you.

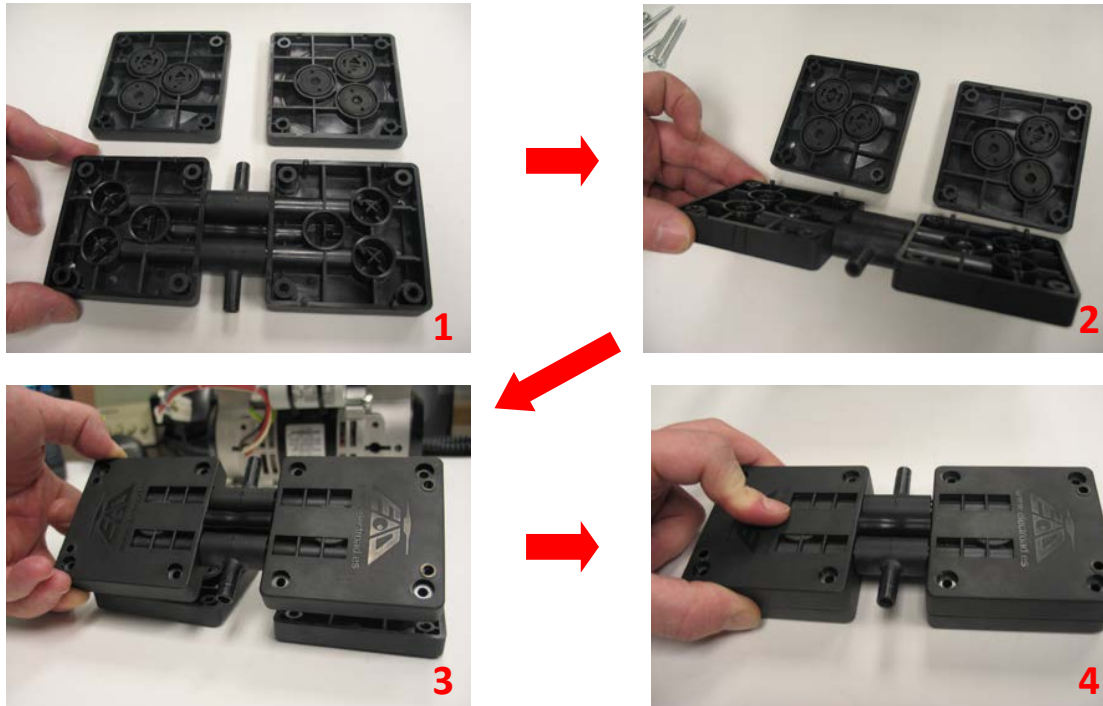
16. Now we can mate the head sections back together with one another as shown below.

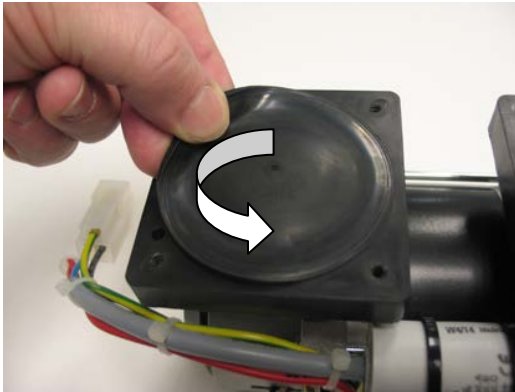
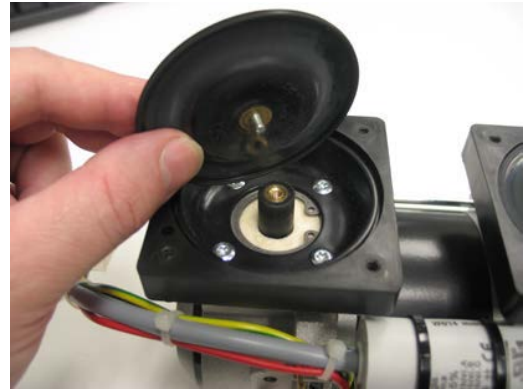
17. Now to replace the two main large membranes on the vacuum pump proper. To remove the membranes, lift up one edge and unscrew the membrane from the vacuum's piston (counter-clockwise to loosen). If the membrane is difficult to remove, gripping with a pair of pliers to help unscrew is fine (the old membranes will be discarded).

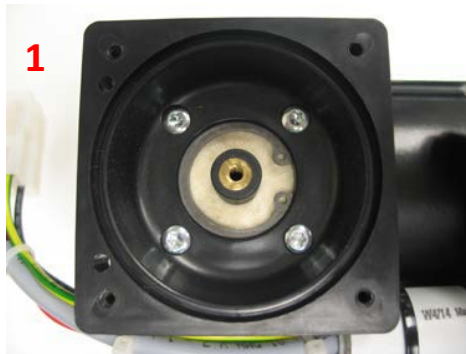
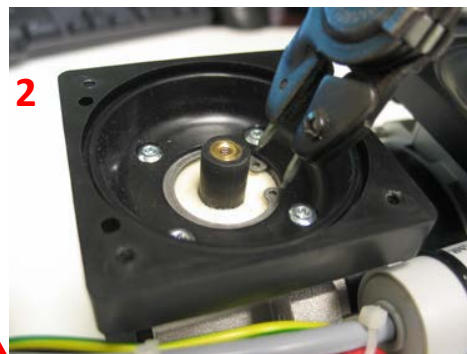
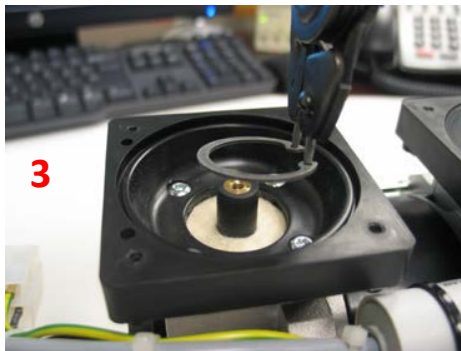
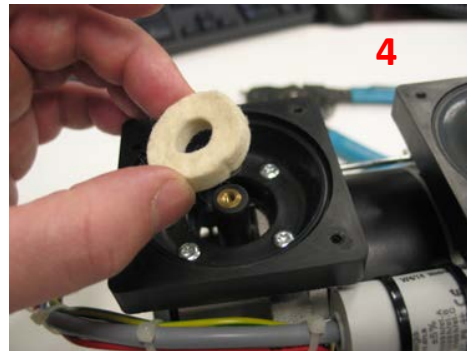
18. We can now see the firm cotton bushing surrounding the piston. Remove the c-clip using a pair of snap-ring pliers (aka clip-ring pliers) and remove the old bushing. Replace with the new bushing included in your rebuild kit.

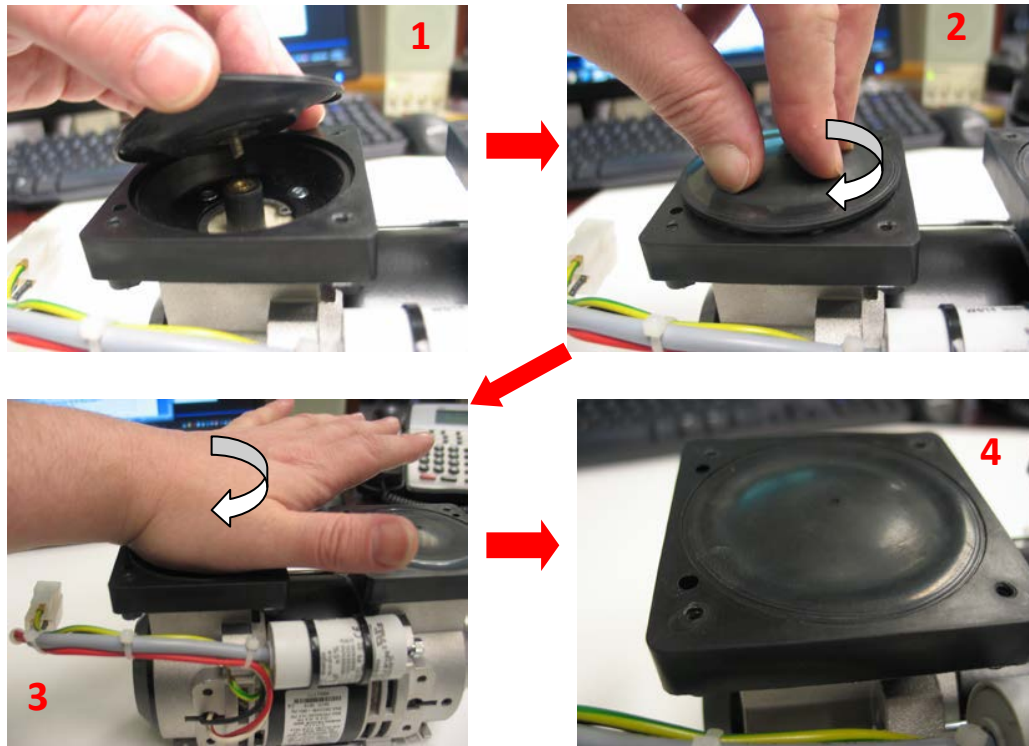
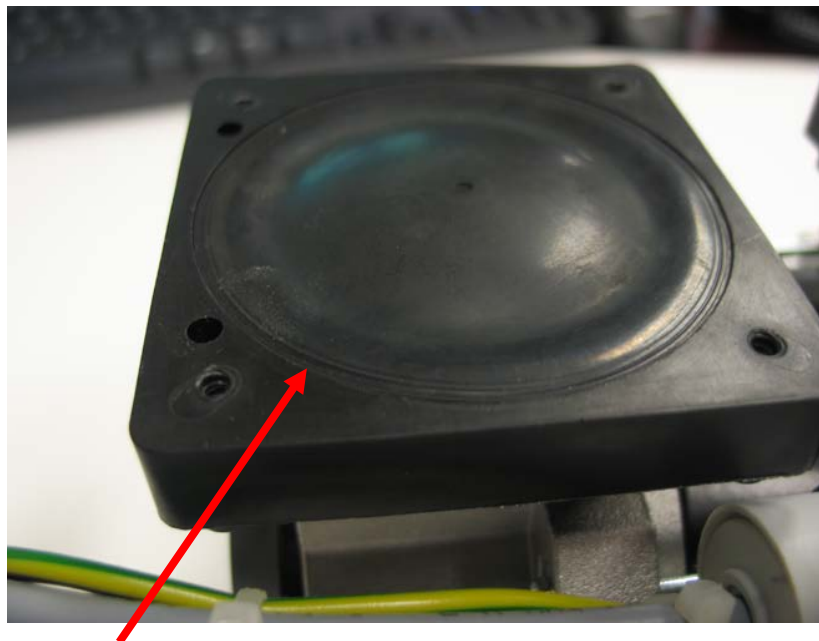
New membrane nice and flush

19. After installing the new bushings, we may now install the main diaphragm membrane to the pump's piston. Simply screw the central threaded post of the membrane into the end of the piston. The black flywheels on either side of the vacuum pump can be manually rotated to position the piston so it is protruding upward as far as it will go; this will assist us in getting the new membrane's post threaded properly, and help to ensure the membrane is fully screwed into place. Be sure to screw the membrane down completely flush to the end of the piston. Pressing down firmly with the palm of your hand while turning clockwise should work, as we do not want to use any tools that could tear/damage the new membrane. If the membrane is not screwed down entirely the vacuum pump will not rotate properly and will be very noisy when operating, or may not rotate at all.

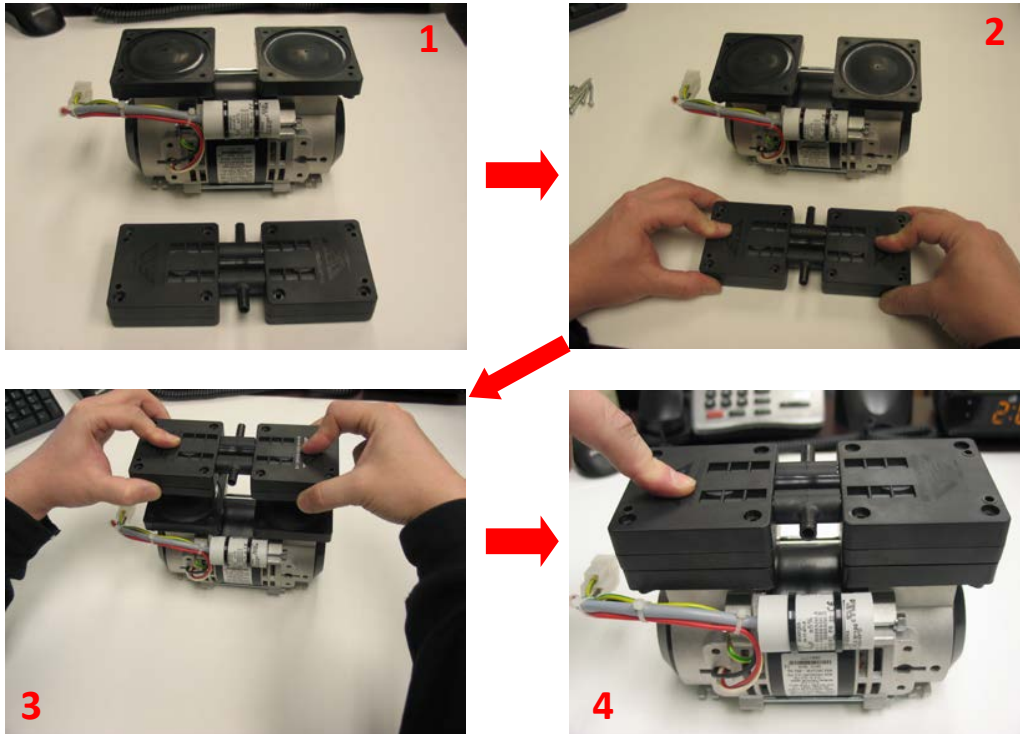
20. Finally we may now replace the head units back onto the vacuum proper. With two hands (to prevent the heads from falling apart) place the head unit back onto the pump and replace the eight screws to secure them in place.

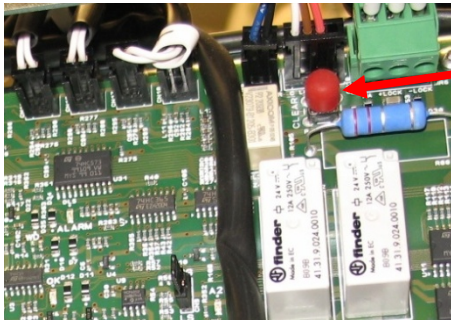
Go to the devices test menu and run the water pump. If the pump is running proceed to step 2. If the pump does not run, check the door motor to verify that the 24VDC power supply is operating. If both the water pump and the door motor do not run check the red reset button on the top/center of the Troll PCB or check fuse F4 (1.25A/250V fast acting part #Fuse-F-1.25A) located on the top/center of the GAM PCB.

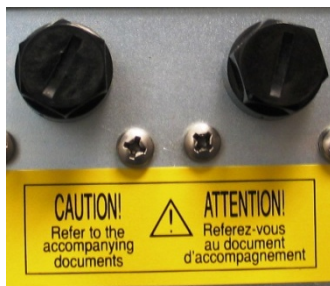
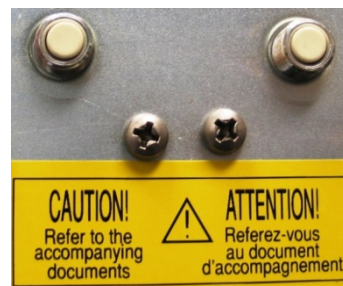
Original Style Thermostat

Remove the black caps on the safety thermostats for the steam generator and band heating element below the condenser coil (heat exchanger) on the rear of the Bravo. Push to reset both thermostats.

Note: The Steam Generator Safety Thermostat (part #97730011) is located on the left and the Band Heating Element Safety Thermostat (part #97730010) is located on the right when facing the rear of the Bravo. A small screwdriver or instrument will be required to reset the original style thermostat.

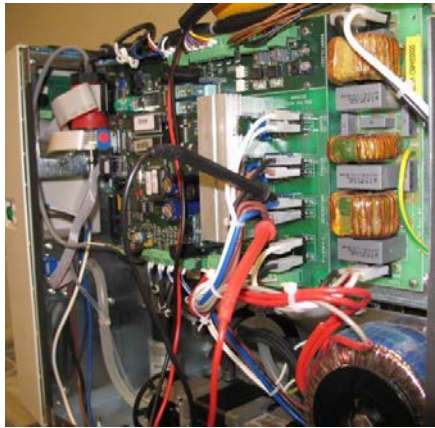
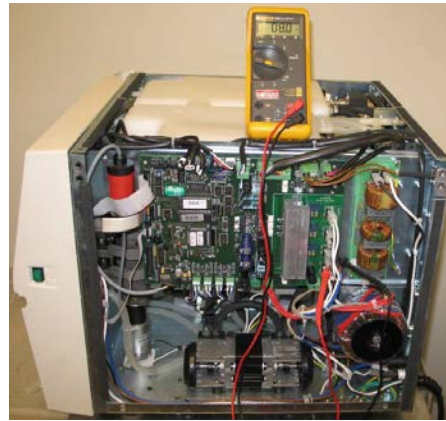
Using an Ohm Meter check the resistance reading of the Steam Generator heating elements. Reading should be approximately 8Ω for 120V & 27Ω for 220V Bravo. If resistance reads 15Ω for 120V or 54Ω for 220V Bravo one of the heating elements is open. We suggest replacing both elements if one is bad. If the reading is showing an open circuit, check the Steam Generator safety thermostat.

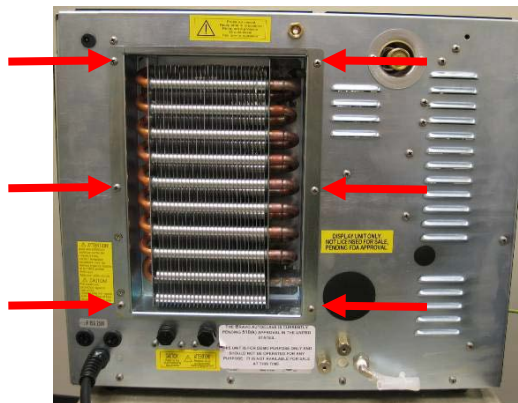
To access the Steam Generator safety thermostat, remove the six screws holding the condenser coil cover.

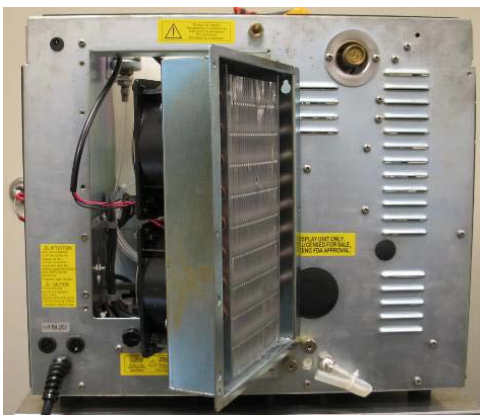
Open the condensing coil assembly to the right to access the safety thermostats.

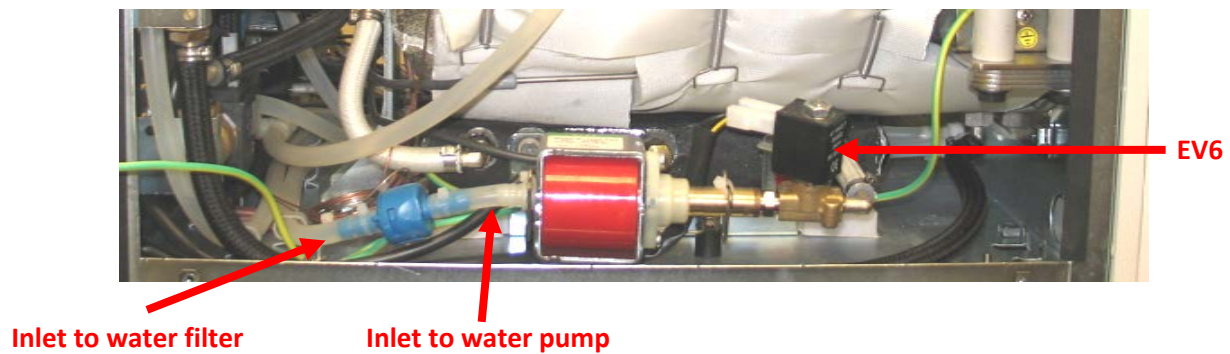
Disconnect the water inlet hose at the water pump. Check for good water flow. If the water is not flowing remove hose from inlet to water filter and check for good water flow. If water flows good, at input to filter and not at output of filter replace filter (part #97290166). If water does not flow good at input to the filter remove the water line from the reservoir to the filter and flush the hose. Then clean the water reservoir. (This is a monthly maintenance procedure, see distilled water reservoir cleaning in this manual). Disconnect the hose at the output of the water pump. Go to devices test menu and run the water pump. If water flow is good from the hose proceed to step 4. If there is no water from the solenoid go to devices test and check to see if EV6 is working properly. (You should hear a clicking noise as you activate and deactivate EV6).

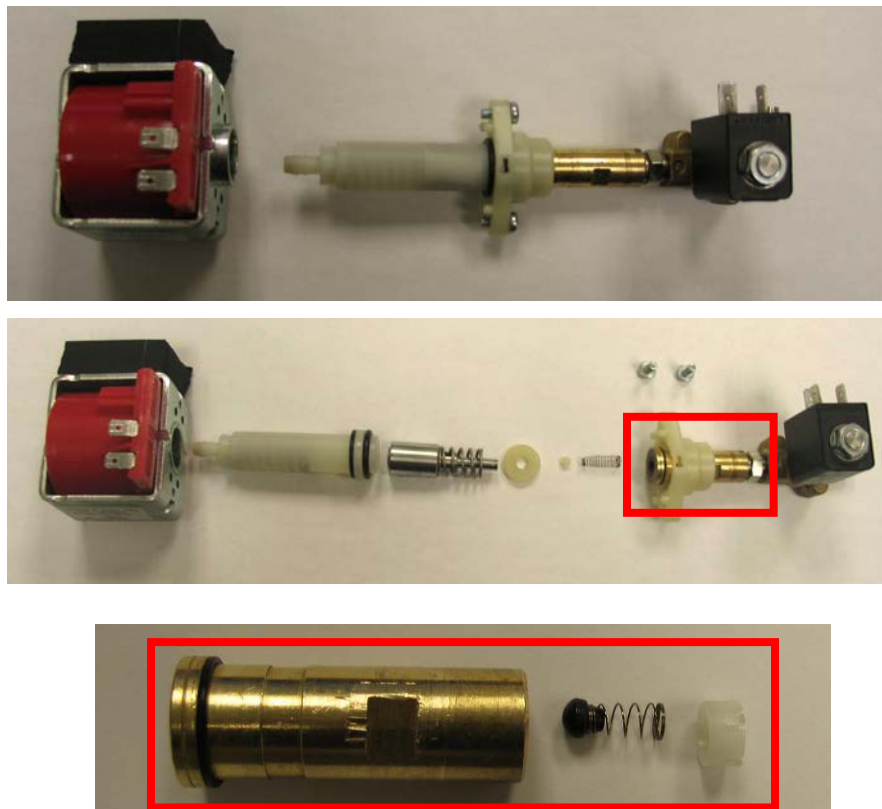
If EV6 is clicking and you have good water flow to the pump, disassemble & inspect the water pump and clean all parts.

Reassemble pump and check for water flow through water pump (part #40000220000) & EV6 (part #40100370000)(water pump complete w/solenoid part #95509145). If water flow is good go to step 4.

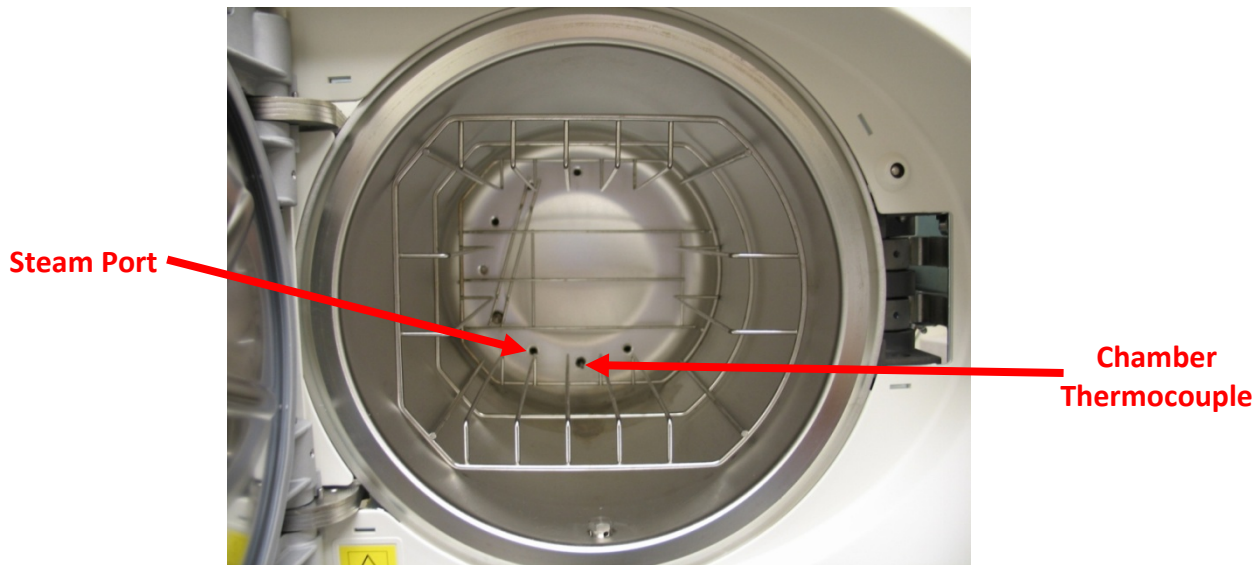
Go to devices test and run the water pump and check for water coming from steam port in chamber.

Note: Have a towel or paper towels available. Water will run to the front of the chamber.

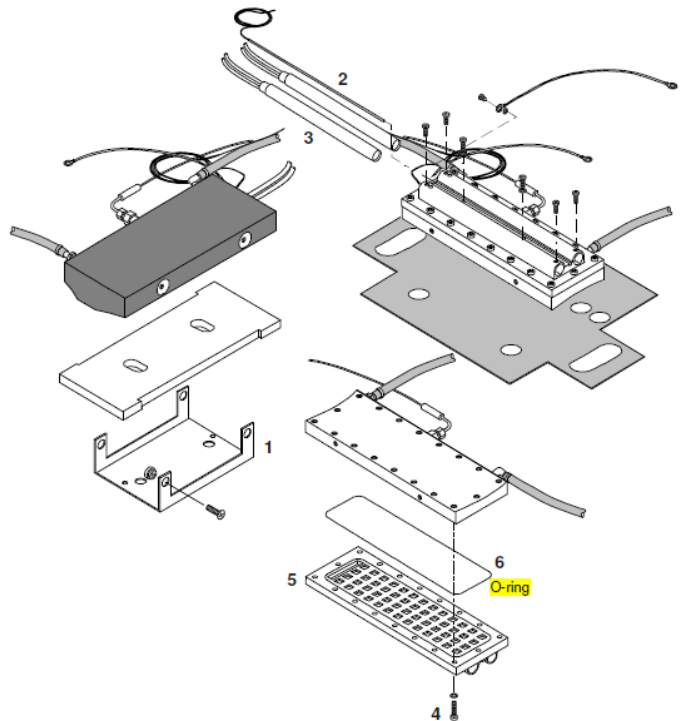
1. Remove the frame cover (see card [Gr7-1](#)).
2. Empty both reservoirs.
3. Remove the water pump group (see card [Gr3-1](#)).
4. Remove the screws from the bottom frame, and move the steam generator as much as possible out the frame.
5. Remove the steam generator from the support (1), and remove the thermo-insulating panel.
6. Remove the bulb of the safety thermostat (2).
7. Loosen the screws and remove the heater cartridges (3).
8. Remove the screws (4) and separate the lower parts (5) from the upper part.
9. Clean the upper part of the steam generator.
10. Replace the lower part, mount a new **O-ring** (6), reassemble and restore the connections proceeding in reverse order.
11. Run a sterilization cycle.

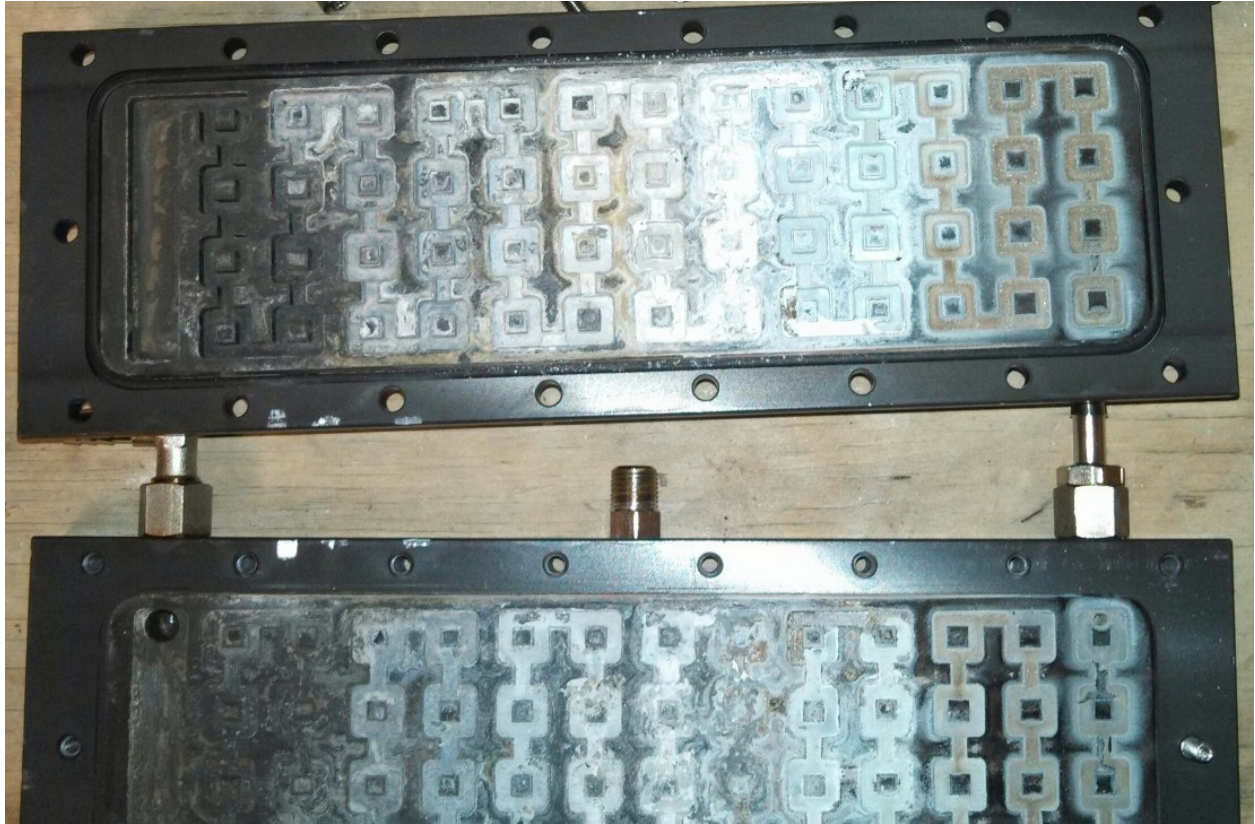
If steam generator is clogged plates will look similar to picture below. White calcium build up is caused by using bad water in the Bravo. Clean plates using distiller cleaner or white vinegar. It is advised to replace the O-ring (part #48100080000) that seals the plates together.

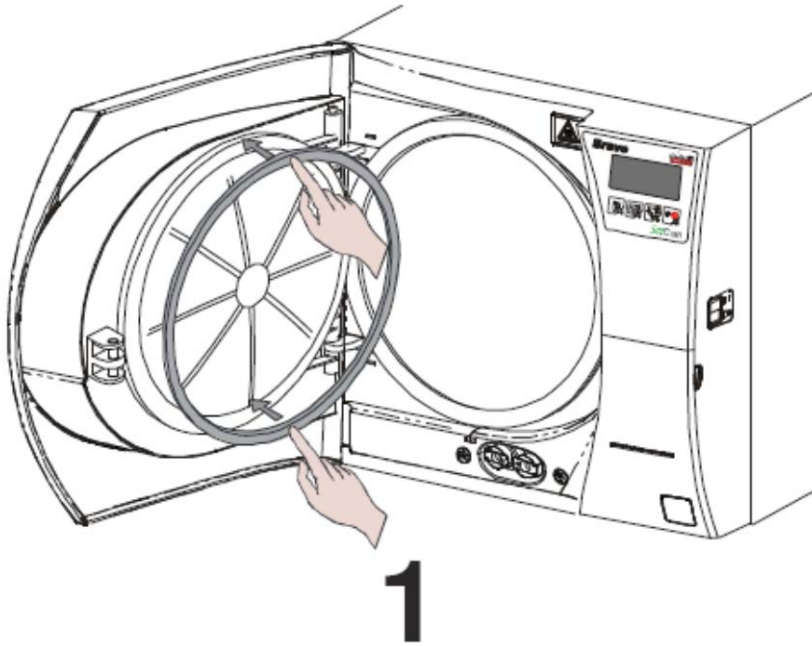
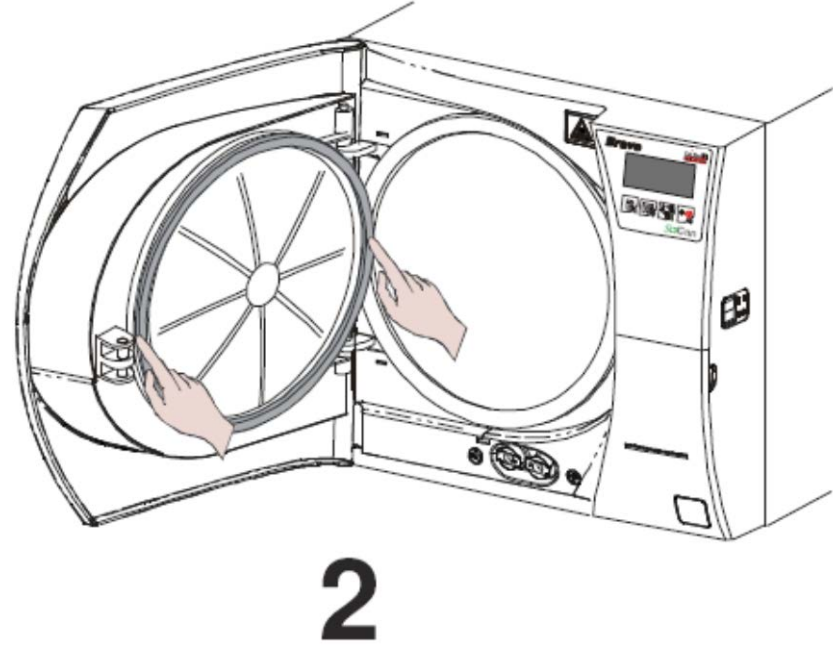
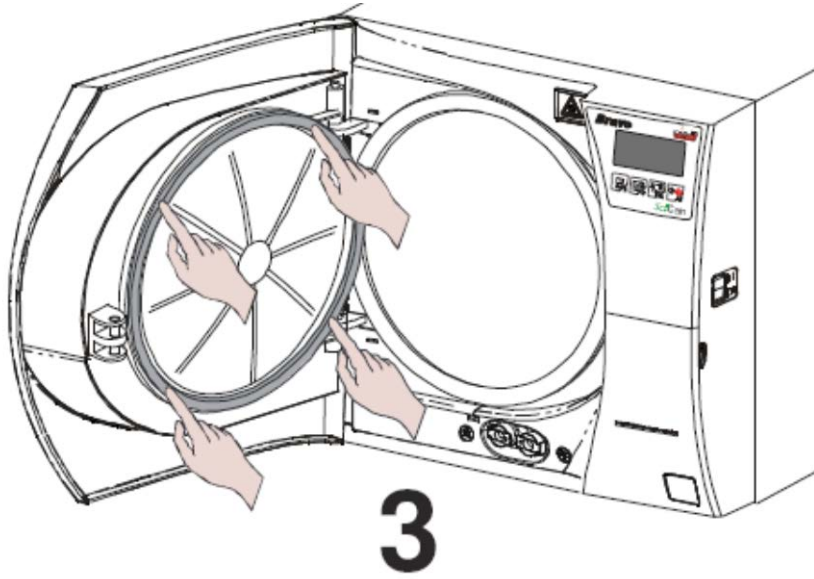
Bravo Door Gasket Replacement

1. Open the door.
2. Remove the old gasket by hand.
3. Clean the door gasket seat to ensure it is debris-free.
4. Install the new door gasket by pressing it into its seat, starting at the top/bottom and on the sides. Then press the remaining gasket completely into its seat.
5. Perform a sterilization cycle.

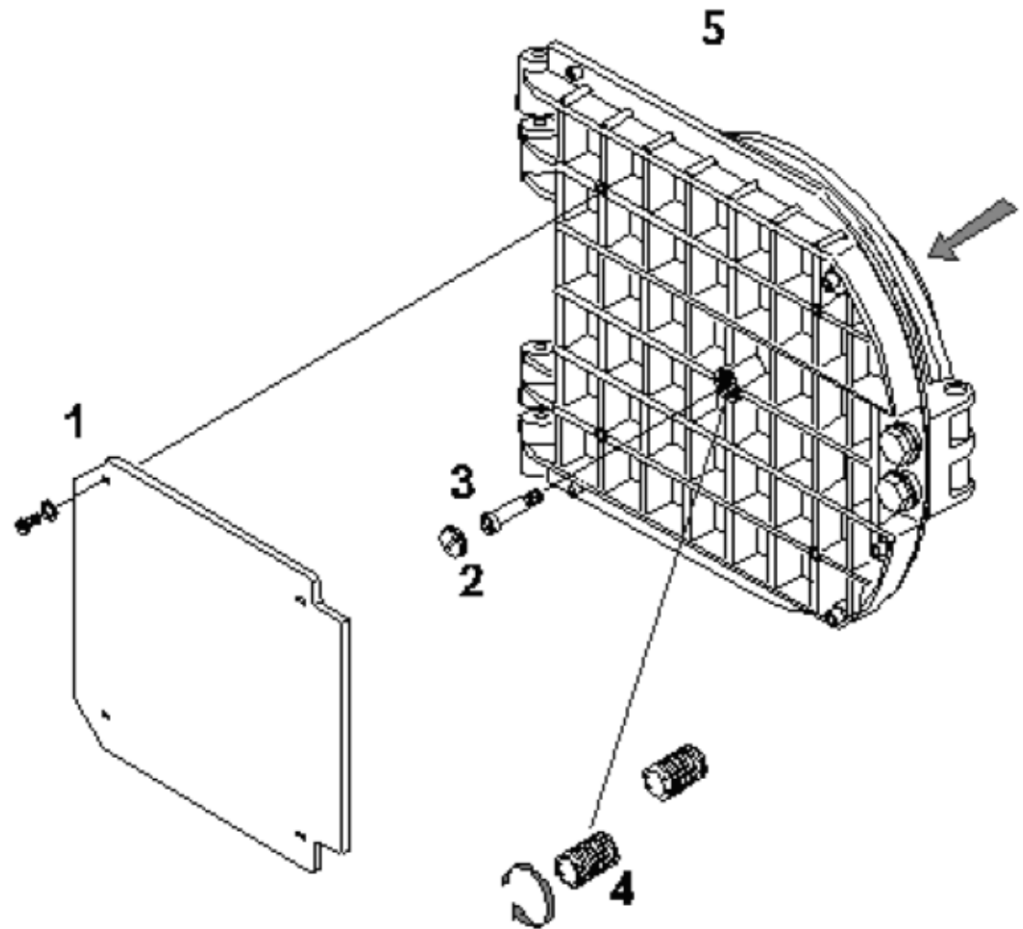
Bravo Door Plate Adjustment

1. Open the door
2. Remove the door cover;
3. Remove the insulating panel (1);
4. Remove the screw-plug (2) at the center of the door;
5. Loosen the threaded bush (4);
6. Maintaining the door dish against the door, turn completely counterclockwise the central threaded bush (4), then turn it $\frac{3}{4}$ clockwise;
7. Remount all items proceeding in reverse order as above;
8. Perform a sterilization cycle.

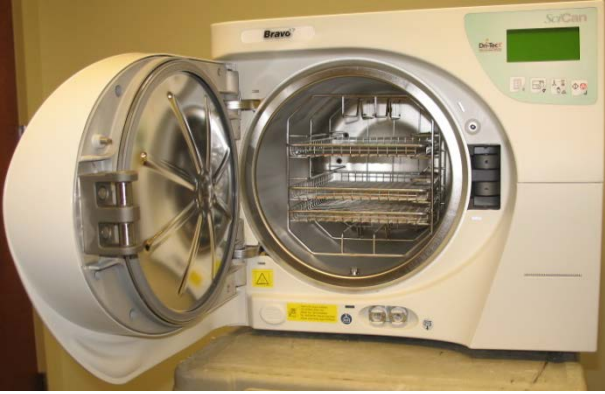
Door Gasket Part #48000050000

Install the new door gasket by pressing the gasket into its seat, first on top, then bottom, then both sides. Once seated on 4 sides, continue to press the remaining gasket completely into its seat.

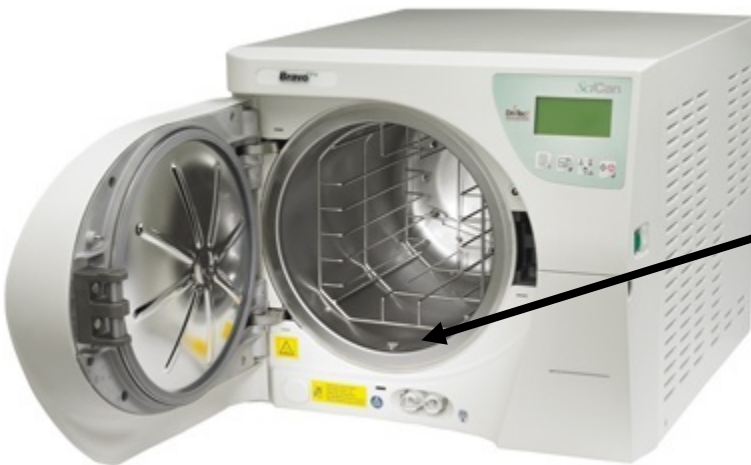
Chamber Drain Filter Part #47200030000 Cleaning & Replacing

Unscrew the fitting from the lower front of the chamber. Remove the screen from the fitting.

Note: Grab the screen on the solid end do not grab in the middle of the screen. You will damage the screen.

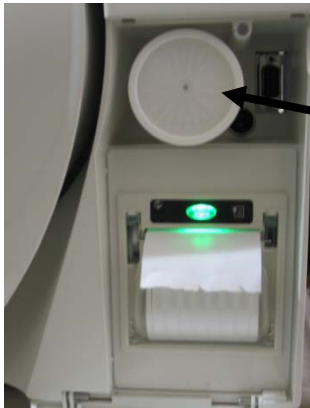
Bacteriological Filter

To replace the bacteriological filter unscrew the filter counterclockwise and replace with new filter.

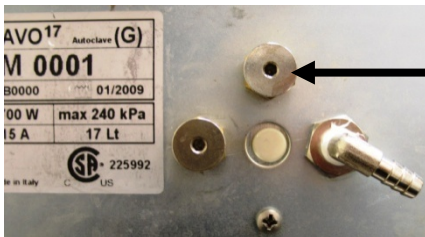
Distilled Water
Drain Port

3. If there is no internal drain tank tubing, go to the rear of the Bravo with an empty container and remove the plug to the Distilled Water Drain Port.

Note: As soon as the plug is removed water will come out of the port.

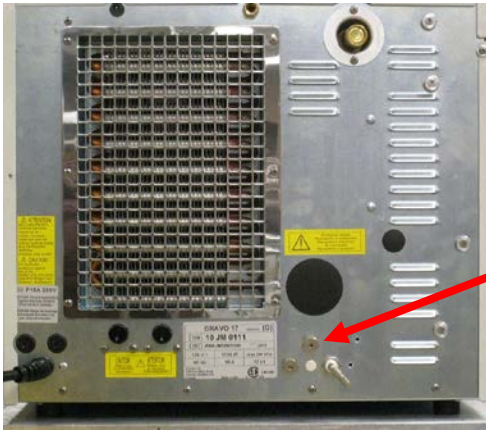
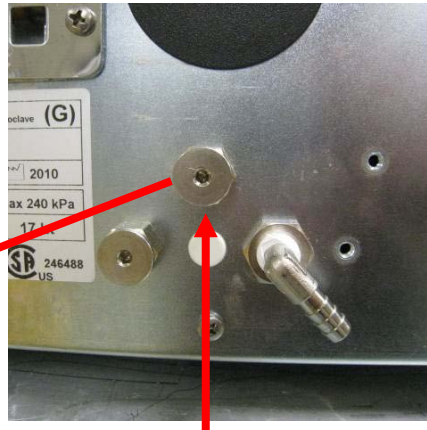
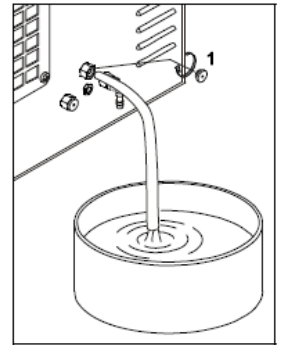
**Distilled Water
Drain Port**

Turn the main power switch OFF and unplug the unit. Go to the rear of the Bravo with an empty container and remove the plug to the clean water drain port. **Note: As soon as the plug is removed water will come out of the port.**

Once the distilled water tank is drained install the elbow fitting into the distilled water drain port.

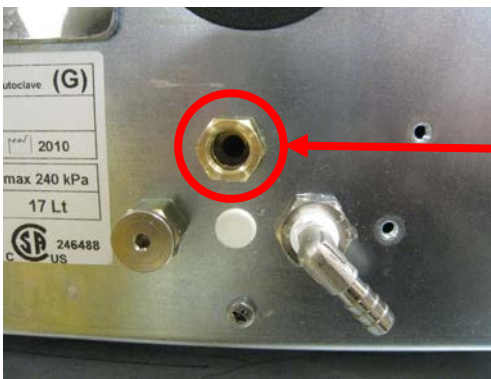
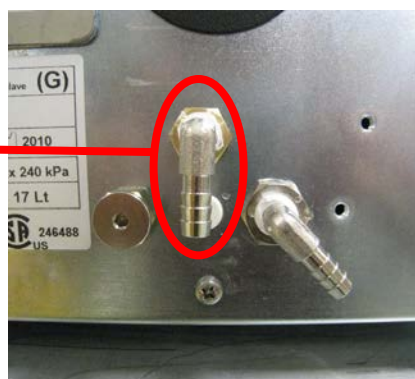
Connect the drain tubing to the elbow fitting using a tie wrap and install the plastic drain tube holder underneath the rear of the Bravo, below the elbow fitting. Feed the drain tubing through the holder. Mount the second drain tube holder underneath the front of the Bravo below the H₂O drain sticker. Make sure the orange plug is installed into the end of the drain tubing.

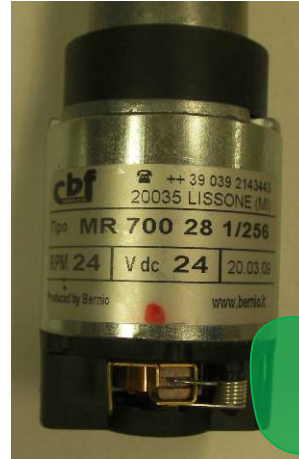
New Motor

Remove the old motor through the opening in the bottom of the Bravo and install the new motor and coupling retained when old motor was removed. Reconnect the white and black wires making sure the white wire is connected to the terminal with the red dot.

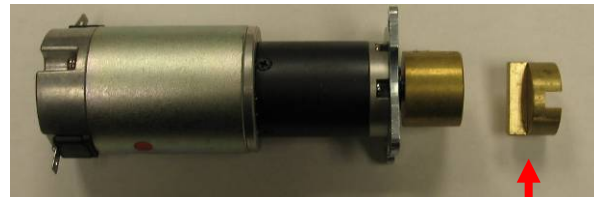
Screw

Top Coupling

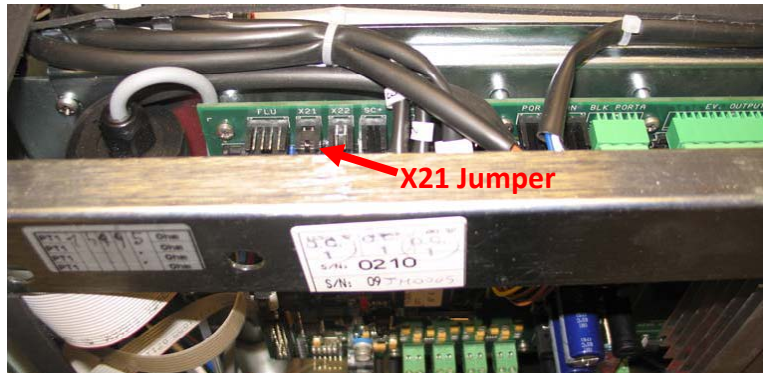
Remove the X21 jumper located above the battery

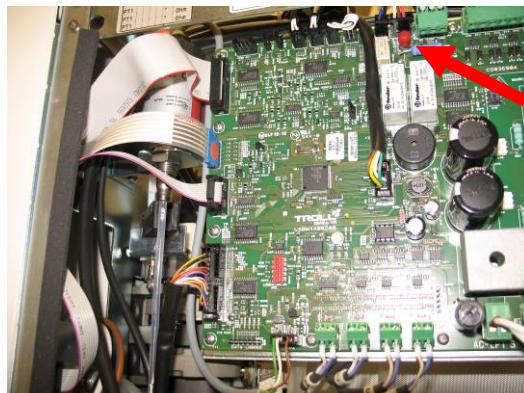
Red Button

If the door overload function has been triggered, there is no more beeping sound when pressing the keypad
remove the cover and reset the red button on the PCB.

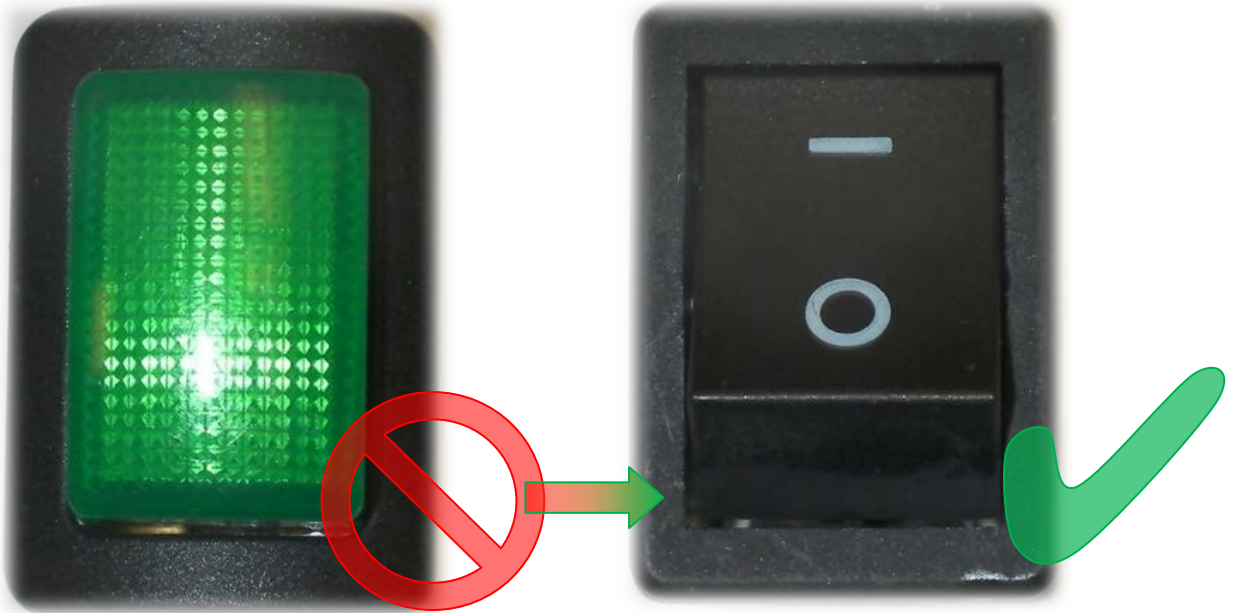
Old Power Switch

New Power Switch

When replacing the power switch connect the wires from the fuse holders to the top terminals of the switch and connect the wires to the filter board to the bottom terminals of the switch. White or blue wires (neutral wires) should be on one side of the switch and black or brown wires (positive wires) on the other side of the switch. The wires can be brought through the mounting hole for the switch and connected to the switch. Then push the switch into the mounting hole and lock into place.

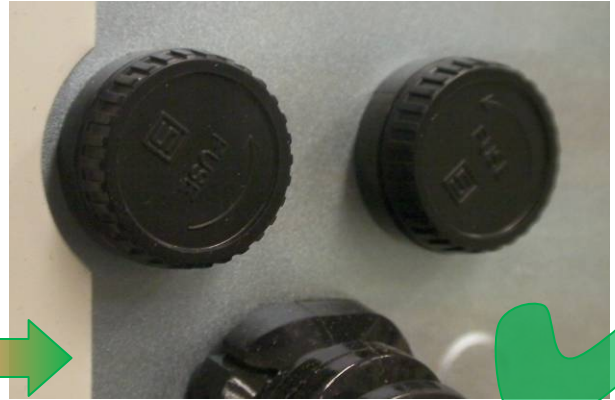
New Fuse Holder

When replacing fuse holders connect white & blue wires to one fuse holder and black and brown wires to the other fuse holder.

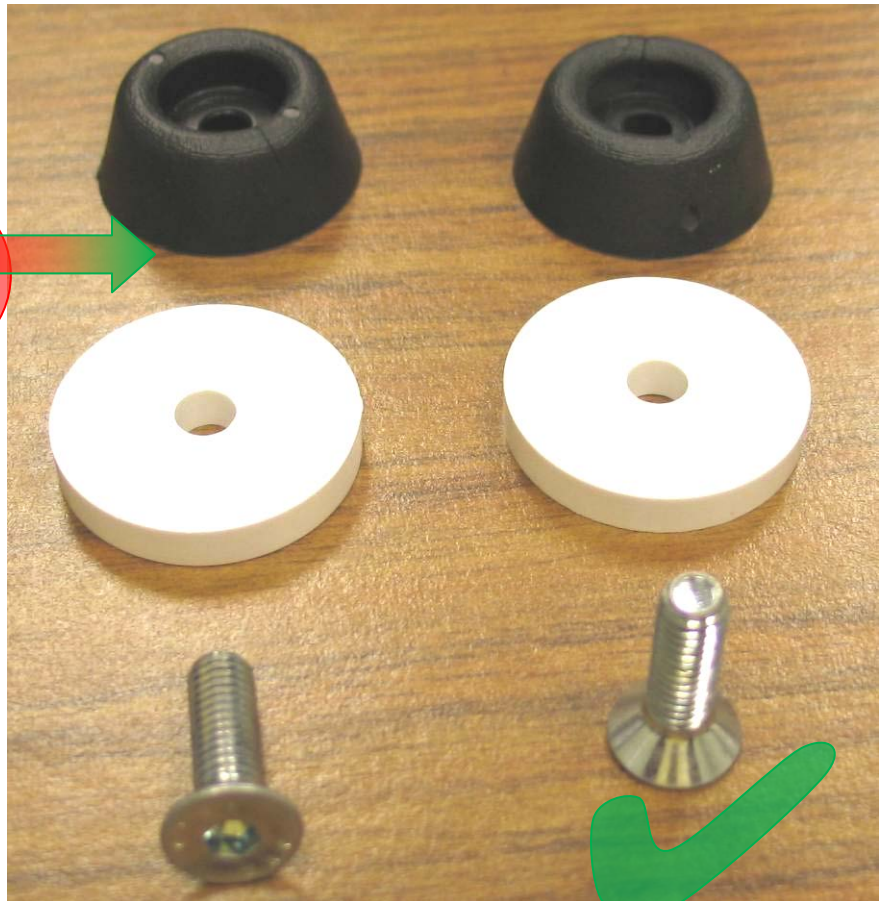
New Leg

Note: Requires 9/16 Allen Wrench

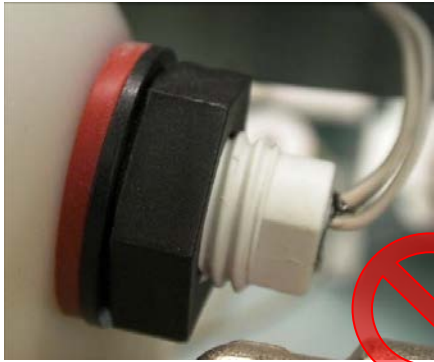
Old Float Switch (orange gasket)

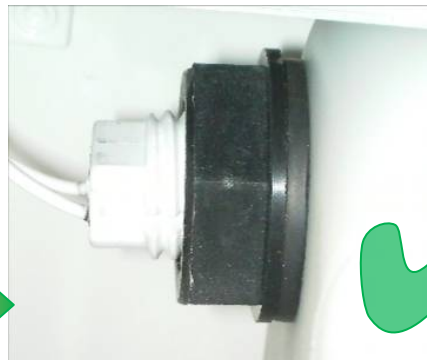
New Float Switch (black gasket)

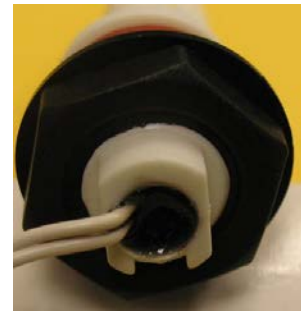
Notch

When install the float switch always observe the direction of the notch on the rear of the switch. The waste water tank switch the notch goes down, the clean water reservoir lower switch (water level minimum) the notch goes down and the clean water reservoir upper switch (water level maximum) the notch goes up.

The float switch wires connect to the top of the PCB on the left. The waste water tank switch connects to terminal SS+, The clean water reservoir lower switch (minimum level) connects to terminal SC- and the clean water reservoir upper switch (maximum level) connects to terminal SC+.
